# SEISMIC CONDITION ASSESSMENT OF TEMPLE A CASE STUDY ON SHIVA-PARBATI TEMPLE

Dinesh Raj Bhattarai

**Abstract—** Shiva Parvati temple is an uncommon shrine built on a four-step brick platform. It stands out particularly due to its three golden pinnacles. It was Bahadur Shah Idea to construct a hybrid temple that incorporated Newar and Rajput style on top of the pavilion built by King Laxmi Narasimha Malla who ruled in the seventeenth century. The temple has been renovated in 1998AD. The golden pinnacle of this temple is quite artistic and one of the best in the Durbar Square. It consists of three tapering spires alternating with four floral stalks on a small platform. It is unique because it departs from the traditional Newar appearance and adopts the Rajput/Mughal style. Shiva-Parvati Temple which is adorned with images of Shiva and his consort Parvati. With its “Shiva-Parvati Temple” historical importance as Monument underlying the UNESCO World Heritage Sites and One which is affected by the Gorkha Earthquake (2015). The main objective of the study is to carry out seismic condition assessment of the temple based on detail damage assessment. A set of Architectural and Structural

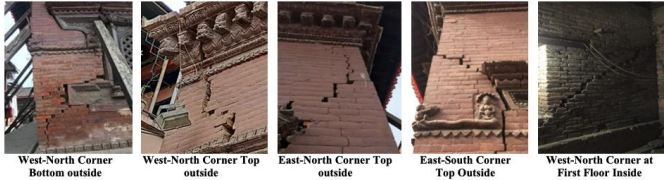
Fig. 8. Shear Cracks in different walls

Shear cracks in the temple are developed when the acting shear on the masonry wall exceeds the resisting shear capacity. Due to seismic behavior of Gorkha earthquake, shear cracks on the surface of the masonry wall of Siva-Parbati temple were observed in different walls of each floor. Maximum shear cracks develop in the wall is about 8'-0" length and about 50mm wide as shown in figure 8.

The most efficient way of Conservation is by providing adequate number of Chukul / Spikes / Wedges to connect the Joist and Wall which increases the lateral strength of wall, Continuous Bands throughout the periphery, Corner Stiches at the Wall Junctions & Wooden Posts and Beams in the form of frame from the inside.

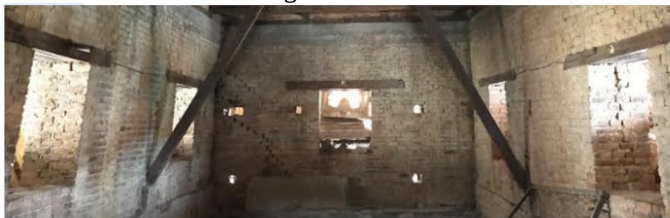
Fig. 9. Cracks observed due to Short Lintel bands

At the opening of each masonry wall, there is a wooden lintel band kept throughout the opening. The bands distribute the stress concentration on the opening to the walls. Due to the short lintel band, a surface crack from the toe of the bands during seismic activity is observed. Major damages were also observed at the west side of the main wall of the first floor due to the inadequate band at the opening. The cracks due to short lintel band are shown in figure 9.
