SEISMIC CONDITION ASSESSMENT OF TEMPLE A CASE STUDY ON SHIVA-PARBATI TEMPLE

Dinesh Raj Bhattra

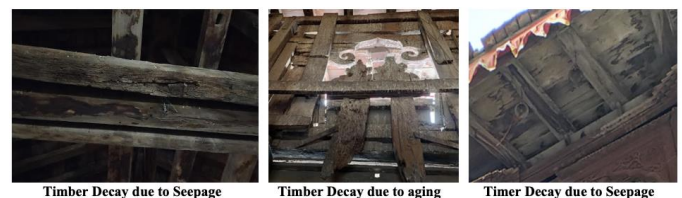
Fig. 7. Status of Timber

Lack of proper connection ties and lintel bands as well as sill bands is seen in the temple. Chukul/Wedges (Wooden pegs) are seen in minimum number that connect the floors and the joists. The overhang portion is mostly affected in the Gorkha Earthquake as dislocation of the struts and eaves from its position. Also, it is observed that fan rafter, purlin and Planks are decayed due to the water leakage in the temple from the pinnacle and also the age after they exposed in the moist condition in the years.

The most efficient way of Conservation is by providing adequate number of Chukul / Spikes / Wedges to connect the Joist and Wall which increases the lateral strength of wall, Continuous Bands throughout the periphery, Corner Stiches at the Wall Junctions & Wooden Posts and Beams in the form of frame from the inside.
