# A REVIEW ON PERFORMANCE OF EARTHFILL DAMS DURING PAST EARTHQUAKES

Roshan Singh Chouhan  
Civil Engineering Department  
IPS Academy  
Institute of Engineering & Science,  
Indore, M.P. India

Swatilekha Guha  
Civil Engineering Department  
IPS Academy  
Institute of Engineering & Science,  
Indore, M.P. India

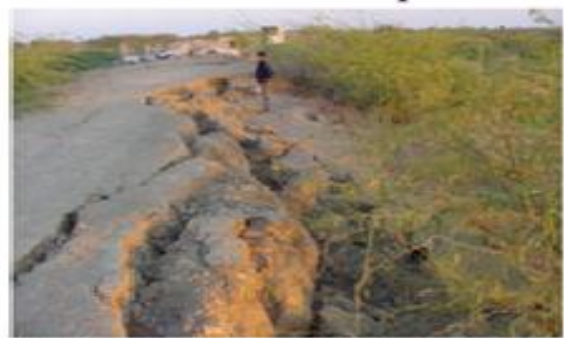
Embankment Failure - Bhuj Earthquake, 2001

Fig.3 Dam failure at Bhuj 2001

Another dam Fatehgadh Dam, constructed in 1979, is an earth dam with a maximum height of 11.6 m and crest length of 4050 m and the Fatehgadh Reservoir was nearly empty during Bhuj Earthquake. However, the alluvium soils underneath the upstream portion of the dam was saturated at that time. Bhuj Earthquake triggered failure near the bottom portion of upstream slope (EERI 2001) possibly because of localized liquefaction near the upstream toe of the dam. The EERI (2001) also found cracks as deep as 1.5 to 1.7 m within the upstream portion of the dam and instability near the top portion of the downstream slope following the earthquake. The problem of appearance of longitudinal cracks may indirectly relate to liquefaction of foundation soils.
