REALIZING LOW COST TOOLING FOR RECONDITIONING OF THREAD ROLL

Abstract— The objective of this experimental work is to find the suitability profile of CBN-L tools application in maintenance of thread rolls. Turning experiment were carried out at constant feed and depth of cut but at different low and medium cutting speeds on similar interrupted and continuous work surfaces. The machining experiments showed that the CBN-L tools performed better at 102 m/min for interrupt surfaces and require higher cutting speeds for continuous surfaces. At a very low speed of 60 m/min the CBN-L tools are prone to chipping of the cutting edge both in continuous and interrupt cutting. It is concluded that a low speed of 100 - 120m/min can be effectively used to remove the damaged threads of the thread rolls and a higher speed of 200 m/min can be used to generate a fresh surface from the same single inserts. SEM reports showed that while abrasion and adhesion were the dominant wear mechanism, diffusion/dissolutions also occur at low cutting speeds along with tribo-chemical wear.

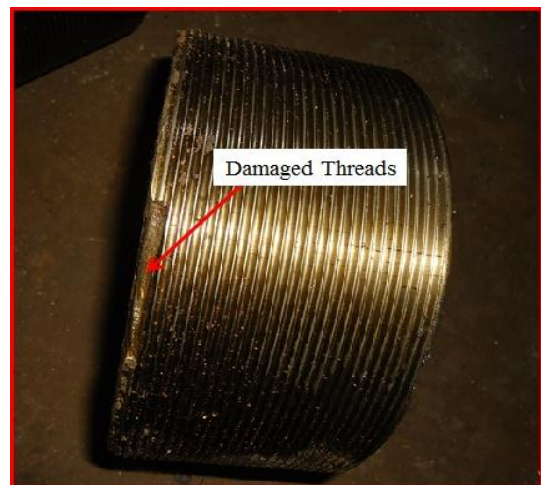
Fig. 1 Damaged threads on thread rolls

by increasing the internal diameter or turning the outer formed surface. Such turnings are extremely difficult because of the high impact forces generated due to interruption of the cut by the grooves on the die surface or damaged threads on the thread rolls or due to hardened layer on the die surfaces. Thread rolls reconditioning or hot forging die surfaces turning are suitable candidate for both continuous and interrupted turning. This study is done with an aim to explore the suitability of using CBN-L tools as an economical mean for maintenance of hardened dies or form tools. Turning experiment were carried out at constant feed and depth of cut but at different low and medium cutting speeds for both interrupt and continuous machining to affirm an economical method of maintenance of form tools and forging dies

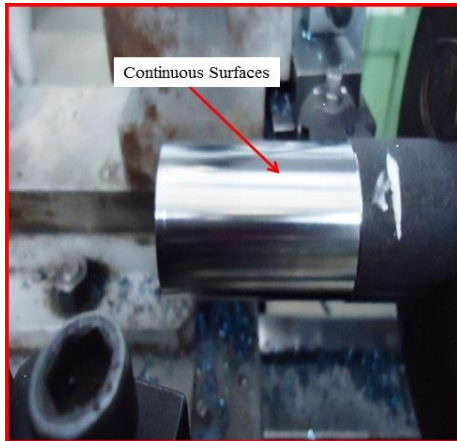
Fig.2 Continuous machining

different tests. For continuous machining, the workpiece of $\varnothing 42 \text{ mm} \times 160 \text{ mm}$ length cylindrical bars as shown in Figure 2 were used whereas for interrupt machining the workpiece with 6-slots were prepared by milling slots of 6 mm width and 8 mm depth on $\varnothing 42 \text{ mm}$ tool steel bar of length 160 mm as shown in Figure 3. The experimental work was done on the workpiece bars after turning the outermost oxidized layer by 1 mm for removal of any scales formed during heat treatment, which could otherwise have an adverse effect on the experimental results.

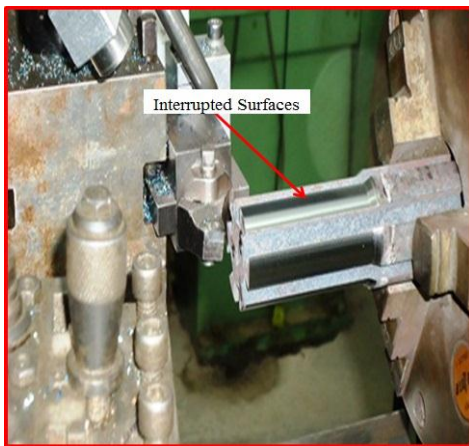
Fig.3 Interrupt machining

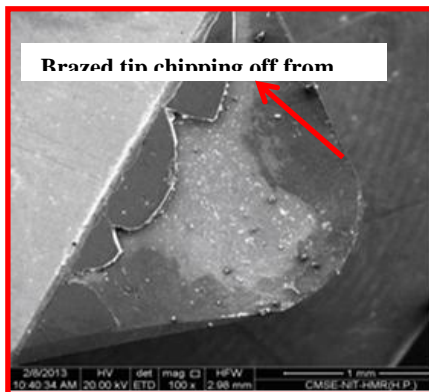
Fig. 4 Interrupt machining at 60 m/min and 15 passes

At a low speed of 60 m/min high surface roughness value were obtained immediately after 4th pass. The test was terminated due to extremely poor surface finish. The poor surface finish is due to rapid wear of the tool at low speeds as suggested by (Omkamuru, 2005). and the tools are susceptible to breakage due to impacts. At low speeds the wear of CBN tool is more mechanical than thermally induced (Chou and Evans, 1999). In this experiment the tool failed due to loss of the supporting shim base where the tool tip is brazed as shown

in Fig. 4 and the failure is only attributed to the difference in material properties of the shim base and CBN tip as identified by Ghani et al (2008).

The continuous impact loads encountered by the tool from the interrupt surface induced high stress and high cutting force resulting in the damage of the CBN tip as shown in Fig.4. Initiations of crater wear on the rake face during interrupt machining as shown in Fig.5 was observed at 102 m/min. It shows different wear modes at different cutting speeds during interrupted cutting with CBN-L tools; “mechanical wear” for lower speeds and “thermal wear” for higher speeds. The tool life of CBN-L tools is very sensitive to cutting speed i.e. it

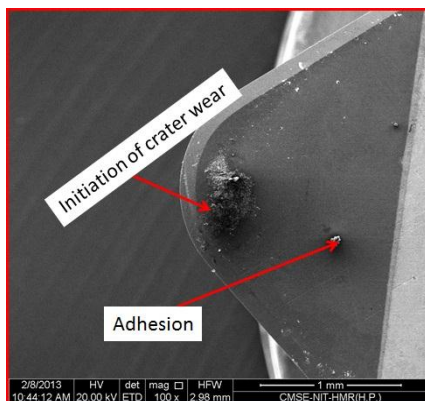
Fig. 5. Interrupt machining at 102 m/min and and 20 passes

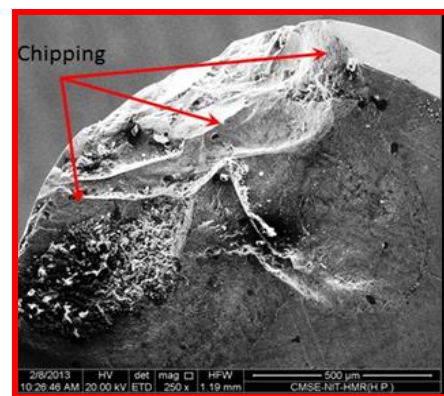
Fig. 6 Continuous machining at 60m/min at 20 passes

During initial passes the tool experienced chipping on the cutting edge, crater wear on the rake face as shown in Figs. 6 and 7, the chipping and the crater increases after each subsequent passes i.e with increased interaction time between tool and work material. The tool experienced a larger crater

In this study Scanning Electron Microscope (SEM) analysis were used to determine the wear mechanism on the cutting tool. Abrasion and adhesion wear mechanism was observed during continuous machining at cutting speeds of 60 m/min and 102 m/min as shown in Figs. 6 and 7 due to the abrasive effect of hard carbides particles of AISI D6 steel. Abrasion is caused by hard particles in the workpiece and also by plucked out CBN grains from the cutting tool. Where the binder material has been abraded by the workpiece, the CBN grains are more easily removed and then contribute to further abrasion (Lua et al 1999). During continuous machining at 102 m/min it was observed that the edges of the tools were subjected to chipping and fracture and the damage is more severe in case of 60 m/min as shown in Fig. 6.

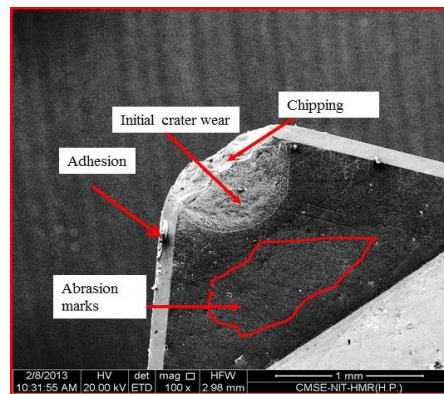
Fig. 7 Continuous machining at 102 m/min at 20 passes

of cut 0.1 mm and feed rate of 0.133 mm/rev constant. Initialization of the crater wear on the rake surface begins immediately and the crater develops as shown in Fig. 7 and extended until it reaches the preceding flank wear. At low speed range this phenomenon weakens the tool nozzle and collapse of the nose is inevitable suggesting these tools are not a good performer for continuous machining below 100 m/min. The nose cutting edges degraded on each subsequent passes more so after four passes. The surface roughness (R_a) measured on the machined surfaces were in the range of value of 0.53 - 2.67 μm initially with fresh inserts at both the speeds. After four passes the surface roughness value exceeded 3.0 μm suggesting the poor performance of CBN-L and its susceptibility to high wear promoted by chipping at a low cutting speed. CBN-L performs better at a speed range of 150-180 m/min as suggested by Chou and Evans (2009).
