SHAPING AND EVALUATION OF PHYSICAL PARAMETERS FOR FARWA LAGOON - LIBYA

Abstract— Farwa complex suffers the effect of pollution, temperature change and the high evaporation process. These effects include but are not limited to physical changes like water properties and the island's shape over time, as results of wave motion and direction. The only study that related to this issue was reported by (M. GERGES & A. DURGHAM, 1982) as part of the UNESCO mission. Their study concluded the results of high salinities, approaching 42 % in winter, 43 % in spring, and 44.5. % in summer, and 43 % in autumn, are most probably obtained through the evaporation process. Here we expressed our work by InSite examination and satellite image to evaluate these physical parameters. Results reported that TDS dropped from 11203 ppm at 27.7 C to 10430 ppm at 29.2 C and the daily average DO was between 3.0 mg/L and 3.7 mg/L. in addition, the value as inflow needs to be increased by extending the bath or the waterway at least 40 m wide and 3 m deep to let more water come thru it. This engineering proposal will raise the water level inside the lagoon as well as, expend the aquatic life in the area.

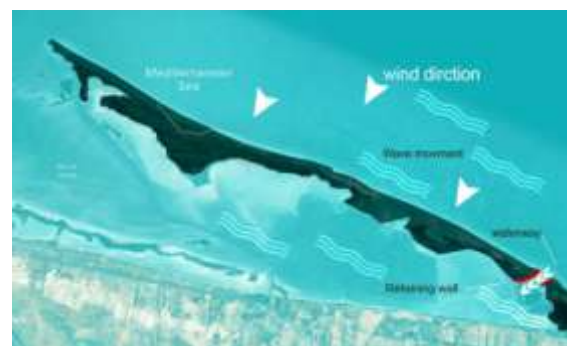
Fig. 3. Showing the wind direction and wav motion out and inside the lagoon

It concerns that the depth of the water related to the low recharging from the open sea. The picture on the side indicates

to this issue as it is clear that the wave motion and the wind direction hit the area from the northeast which handle the reformation of the island shape over the time.

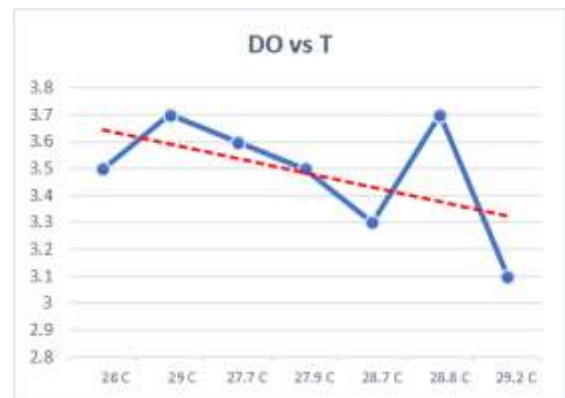
Fig. 6. DO vs T for seven different locations at the site of study

The surface water temperature is found to be in the range between 27.8 C0 and 29C0. The daily average DO between 3.0 mg/L and 3.7 mg/L. from the figure and after marketing all the points we got; it is clear that the Do is dropping by increasing the water temperature.

Moreover, points located close to the edge of the island have higher Do related to various aquatic organisms that live in the reservoirs area.
