# SEISMIC CONDITION ASSESSMENT OF TEMPLE A CASE STUDY ON SHIVA-PARBATI TEMPLE

Dinesh Raj Bhattarai

**Abstract—** Shiva Parvati temple is an uncommon shrine built on a four-step brick platform. It stands out particularly due to its three golden pinnacles. It was Bahadur Shah Idea to construct a hybrid temple that incorporated Newar and Rajput style on top of the pavilion built by King Laxmi Narasimha Malla who ruled in the seventeenth century. The temple has been renovated in 1998AD. The golden pinnacle of this temple is quite artistic and one of the best in the Durbar Square. It consists of three tapering spires alternating with four floral stalks on a small platform. It is unique because it departs from the traditional Newar appearance and adopts the Rajput/Mughal style. Shiva-Parvati Temple which is adorned with images of Shiva and his consort Parvati. With its “Shiva-Parvati Temple” historical importance as Monument underlying the UNESCO World Heritage Sites and One which is affected by the Gorkha Earthquake (2015). The main objective of the study is to carry out seismic condition assessment of the temple based on detail damage assessment. A set of Architectural and Structural

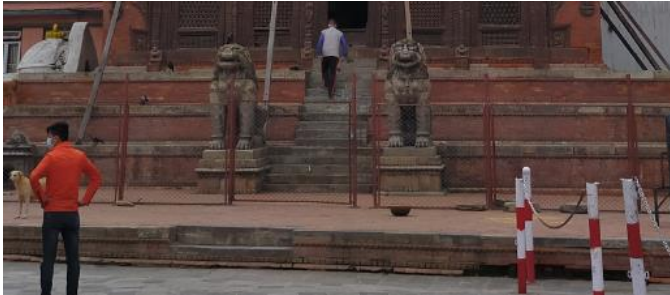
Fig. 2. Section of footing

The foundation is not exposed in the Shiva-Parvati Temple. The foundation may have a stepped footing according to the literature review and study of the similar temples. But temple has a Wide Plinth as shown in figure 2.

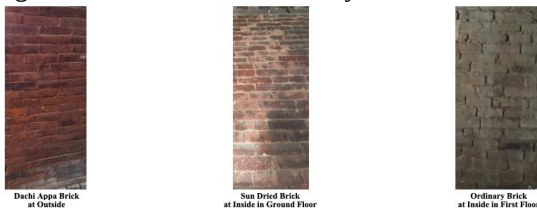
Fig. 3. Section of wall

It was observed at site that, the external brick wall is exposed of Single Layer of Dachipa Bricks (having a thickness of 4-5" thick) on all the elevation sides, ordinary brick masonry in the middle portion and Sundried brick masonry work to the inside, which can be depicted in figure 3 representing from left to right. However, the middle portion of the wall is not visible; it might be filled with brick masonry works in different bonds.
