# INVESTIGATING THE CAUSES OF FREQUENT FAILURES IN FLEXIBLE PAVEMENTS ON HIGHWAYS IN BANGLADESH: A CASE STUDY OF THE DHAKA–SYLHET CORRIDOR

Subrata Chowdhury  
Associate Professor,  
Department of Civil Engineering  
Stamford University Bangladesh  
Dhaka, Bangladesh

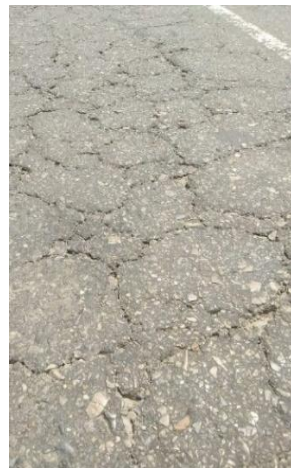
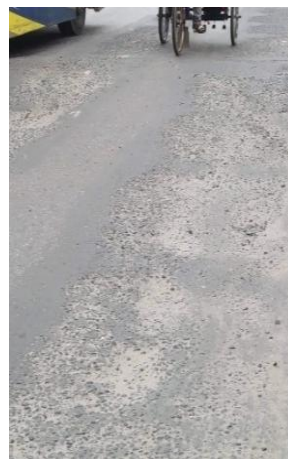
- **Alligator cracking (8 sites):** These cracks typically develop from asphalt fatigue caused by repeated axle loading. Their occurrence indicates insufficient pavement thickness or degradation of the asphalt binder and aggregates, pointing to fatigue-related structural inadequacy.

- **Slippage cracking (7 sites):** Characterized by crescent-shaped cracks, these are generally associated with poor bonding between successive pavement layers. Such failures reflect deficiencies in construction quality control, particularly inadequate tack coat application.

- **Transverse cracking (10 sites):** These cracks are primarily linked to temperature variations and thermal stresses. Their presence indicates insufficient flexibility of the asphalt mixture or inadequate accommodation of thermal expansion and contraction.

- **Potholes (7 sites):** These originated from untreated cracks that allowed water infiltration, which progressively weakened the underlying layers. The process was exacerbated by ineffective drainage and delayed maintenance responses.

Fig. 2. Photographs Presenting: (a) Alligator Cracking (Location: Ruposhi); (b) Slippage Cracking (Location: Madhubdi); (c) Transverse Cracking (Location: Ruporshi); (d) Pathholes (Location: Madhubdi); (e) Raveling (Location: Bhulta); (f) Bleeding (Location: Madhubdi); (g) Corrugation and Shoving (Location: Bhulta); & (h) Depression (Location: Ruposhi).

- **Raveling (10 locations):** Raveling, characterized by the gradual detachment of aggregate particles, occurs due to binder hardening and poor bonding between asphalt and aggregates. This progressive deterioration eventually causes surface disintegration and exposes the underlying base layer.
- **Bleeding (12 locations):** Bleeding results from excessive binder content combined with inadequate surface drainage, leading to binder migration upward. This forms a shiny, sticky film on the pavement surface, which significantly decreases skid resistance.
- **Corrugation and shoving (19 locations):** The most prevalent distress type, corrugation and shoving, arises from unstable asphalt layers subjected to shear deformation under repeated traffic loads. This not only compromises ride quality but also highlights severe deficiencies in mix stability.

- **Depressions (6 sites):** These localized settlements were caused by weak or saturated subgrade soils, often aggravated by water accumulation and inadequate compaction during construction.

1. **Improve Drainage Provisions:** Construct adequately deep side drains, stabilize erosion-prone embankments, and institute scheduled inspections and cleaning operations. Well-functioning drainage is essential to safeguard the subgrade from moisture damage, thereby reducing the occurrence of potholes and surface deformation.

2. **Adopt Proactive Maintenance Practices:** Implement scheduled interventions such as sealing of cracks, application of surface overlays, and periodic resurfacing. Addressing pavement distress at its early stages extends service life, lowers long-term repair costs, and minimizes the risk of structural deterioration.
