# REALIZING LOW COST TOOLING FOR RECONDITIONING OF THREAD ROLL

**Abstract**— The objective of this experimental work is to find the suitability profile of CBN-L tools application in maintenance of thread rolls. Turning experiment were carried out at constant feed and depth of cut but at different low and medium cutting speeds on similar interrupted and continuous work surfaces. The machining experiments showed that the CBN-L tools performed better at 102 m/min for interrupt surfaces and require higher cutting speeds for continuous surfaces. At a very low speed of 60 m/min the CBN-L tools are prone to chipping of the cutting edge both in continuous and interrupt cutting. It is concluded that a low speed of 100 - 120m/min can be effectively used to remove the damaged threads of the thread rolls and a higher speed of 200 m/min can be used to generate a fresh surface from the same single inserts. SEM reports showed that while abrasion and adhesion were the dominant wear mechanism, diffusion/dissolutions also occur at low cutting speeds along with tribo-chemical wear.

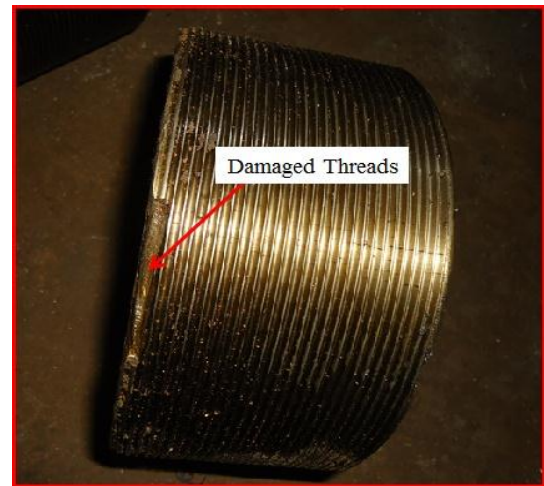
Fig. 1 Damaged threads on thread rolls

by increasing the internal diameter or turning the outer formed surface. Such turnings are extremely difficult because of the high impact forces generated due to interruption of the cut by the grooves on the die surface or damaged threads on the thread rolls or due to hardened layer on the die surfaces. Thread rolls reconditioning or hot forging die surfaces turning are suitable candidate for both continuous and interrupted turning. This study is done with an aim to explore the suitability of using CBN-L tools as an economical mean for maintenance of hardened dies or form tools. Turning experiment were carried out at constant feed and depth of cut but at different low and medium cutting speeds for both interrupt and continuous machining to affirm an economical method of maintenance of form tools and forging dies
