INTERNATIONAL JOURNAL  
OF ENGINEERING APPLIED SCIENCE  
AND TECHNOLOGY

VOLUME : 7    ISSUE : 05    Print / Issue Publication Date: 06-Nov-2022

# SHAPING AND EVALUATION OF PHYSICAL PARAMETERS FOR FARWA LAGOON - LIBYA

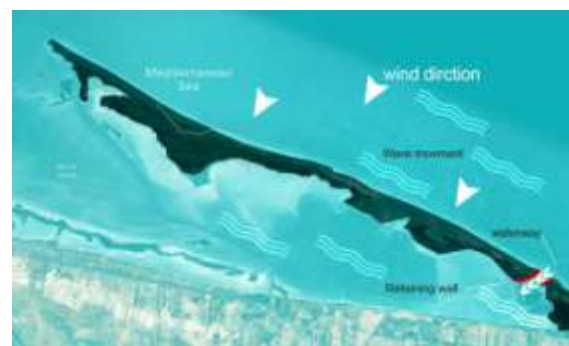
Fig. 3. Showing the wind direction and wav motion out and inside the lagoon

It concerns that the depth of the water related to the low recharging from the open sea. The picture on the side indicates

to this issue as it is clear that the wave motion and the wind direction hit the area from the northeast which handle the reformation of the island shape over the time.

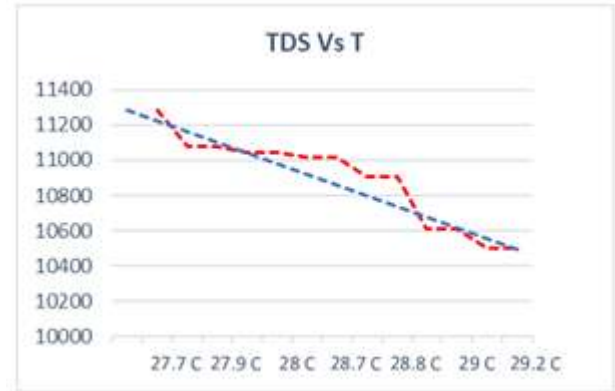
Fig. 5. TDS (ppm) vs T (Co) for seven different locations at the site of study

The total dissolved solids (TDS) in the Farwa lagoon are influenced by temperature and the conductivity of ions in water depends on the temperature of the water. Ions move faster when the water is warm.

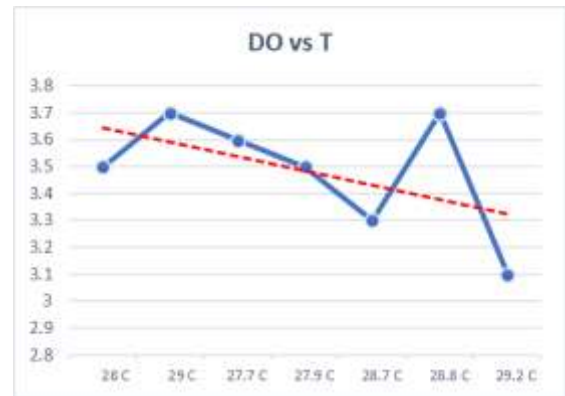
Fig. 6. DO vs T for seven different locations at the site of study

The surface water temperature is found to be in the range between 27.8 C0 and 29C0. The daily average DO between 3.0 mg/L and 3.7 mg/L. from the figure and after marketing all the points we got; it is clear that the Do is dropping by increasing the water temperature.

Moreover, points located close to the edge of the island have higher Do related to various aquatic organisms that live in the reservoirs area.

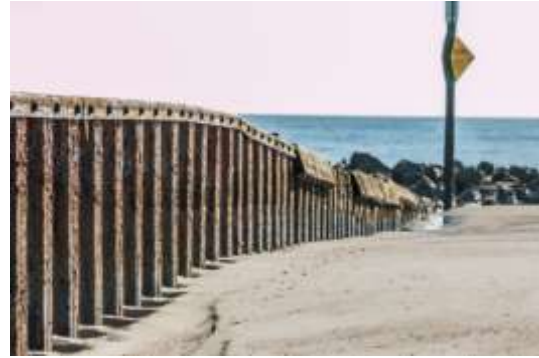
Fig. 8. showing Steel and concrete retaining wall as an example

- Build retaining walls around the edge where the trench has been made. The retaining walls should be made with an engineering design to provide stability and a longer lifetime.
